***Iowa Farmer Today***

# Safety Watch: Various risks associated with pressure washing

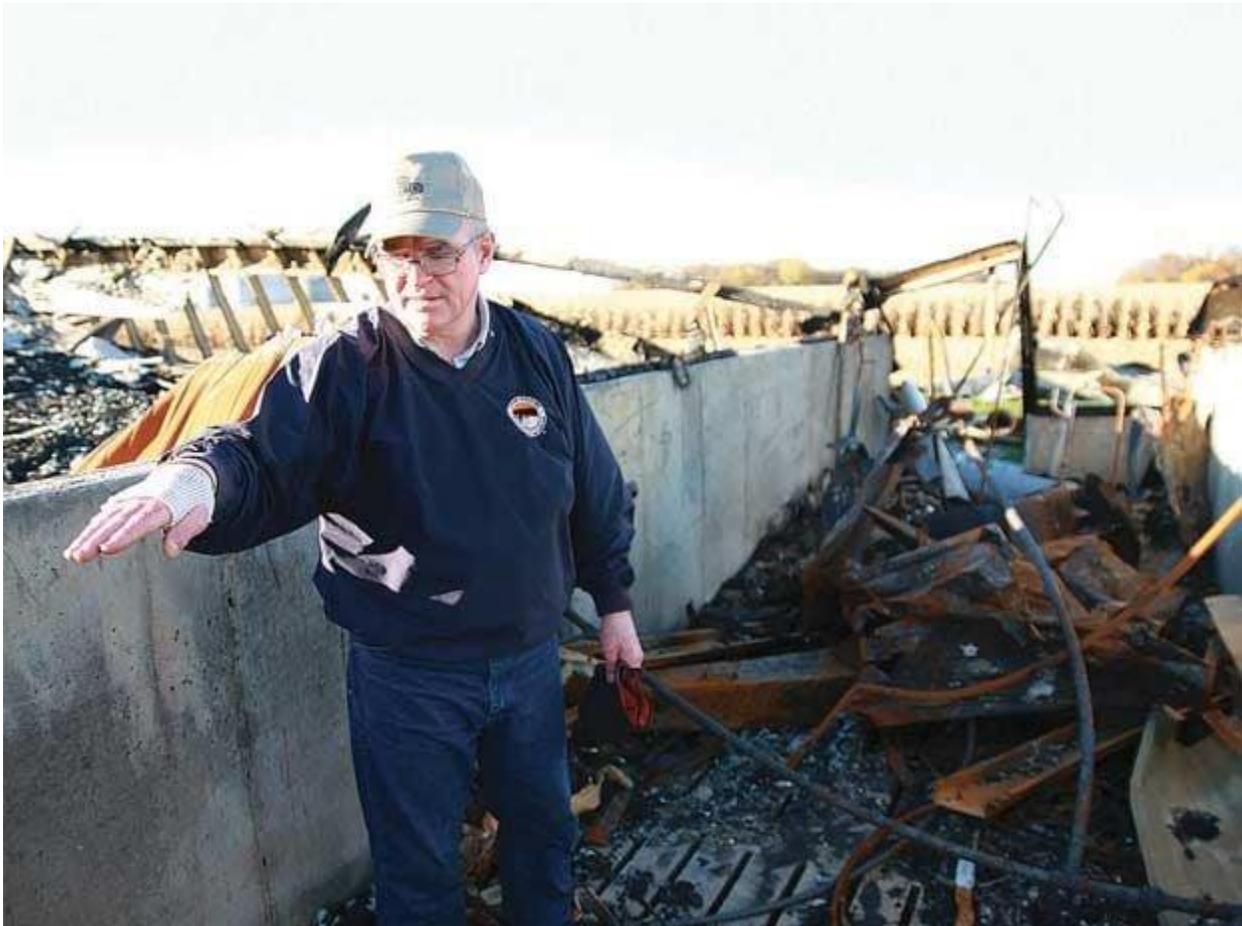
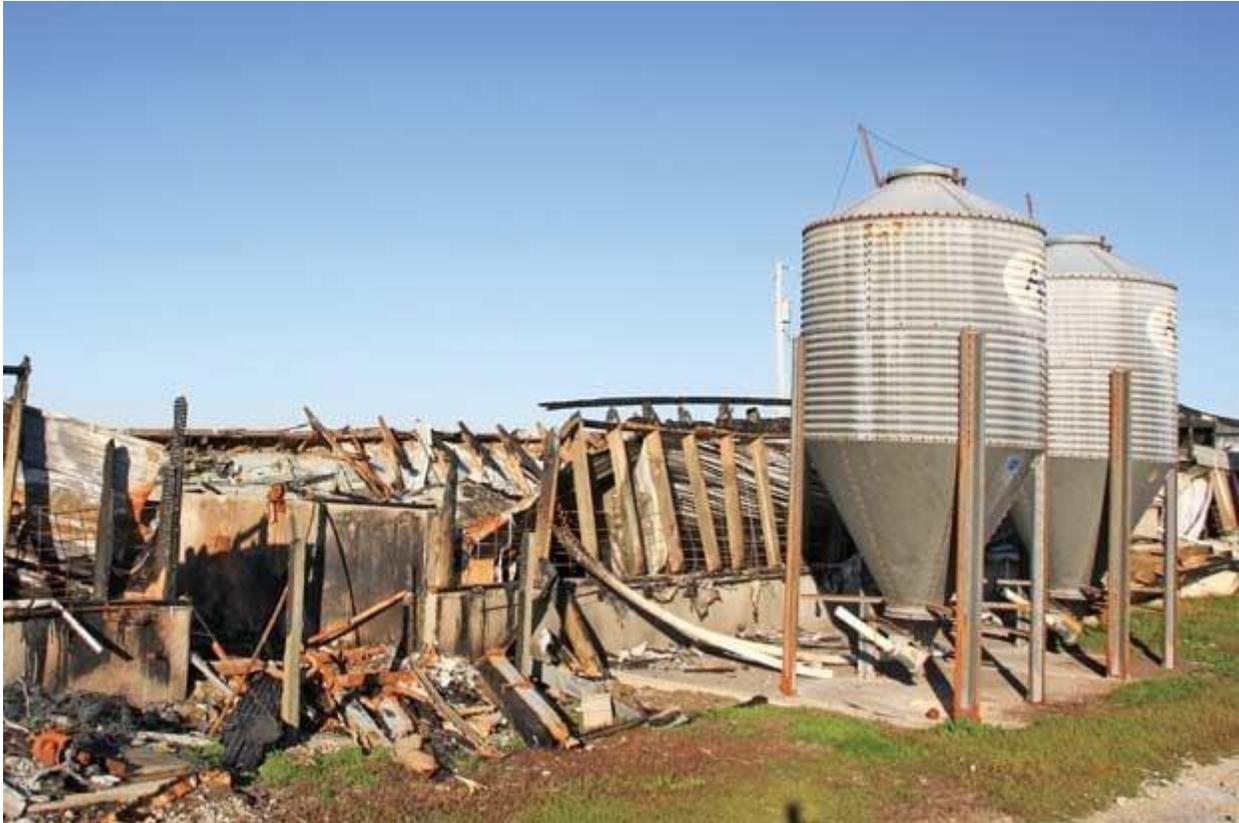
Leon Sheets describes the fire and explosion that occurred when he was pressure washing a finishing barn room with foaming manure in the pit below. A pilot light provided the ignition source for explosive methane gas that was released into the air when the foam layer was disrupted by water spray.

The cause of this flash fire was methane gas released into the air when water spray broke the foam bubbles below the slatted floor.

The LP heater in the room hadn't cycled on, but its open pilot light provided the ignition source when methane rapidly reached the lower explosive limit concentration in the closed room.

His precautions prior to pressure washing now include making sure all doors, windows and curtains are open with fans running for maximum ventilation to dissipate gases; all heaters, pilot lights and automated feeding systems must be turned off to eliminate ignition sources; and he maintains a lower level of manure depth in the pit with the foaming phenomenon.
